Test report

T211-0305/15

Satellite Communication Terminal

BlueTraker VMS

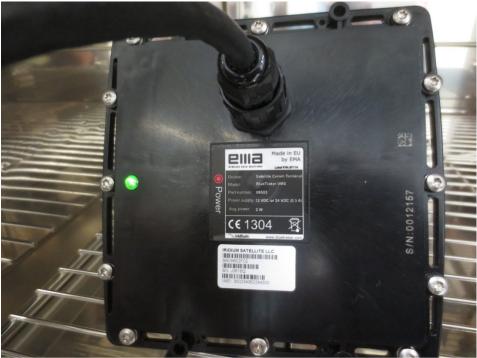
Figure 1

Satellite Communication Terminal BlueTraker VMS (Figure 1) was subjected to climatic test according to standard EN 60068-2-14:2009. The sample was operating during the test.

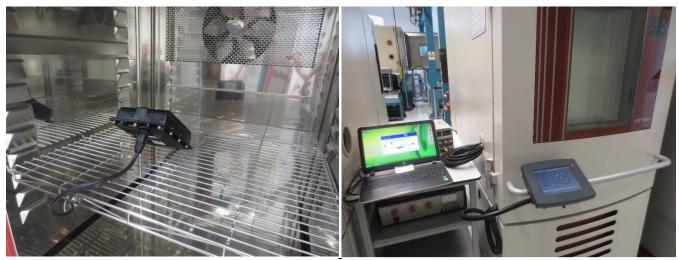
Figure 2 Figure 3

The sample was placed into climatic chamber (Figure 2). The sample was operating during the test and monitored via PC provided by applicant (Figure 3).

- Temperature: $T_{max} = +85^{\circ}C$, $T_{min} = -40^{\circ}C$,
- Dwell time at T_{max} and T_{min} : 4 hours,
- Transfer duration 1 hour between T_{max} and $T_{\text{min},,}$
- Test duration: 1 cycle.

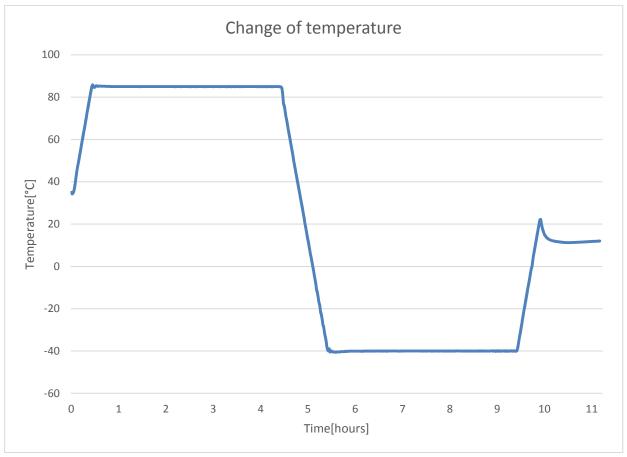
Figure 4

Temperature graph measured in climatic chamber is presented in Figure 4.

During and after the test the sample was operating without disturbance.
